REPORT ON STAKEHOLDER ASSESSMENT OF THE WESTERN AREA WATER CATCHMENT AREAS

National Water Resources Management Agency (NWRMA)

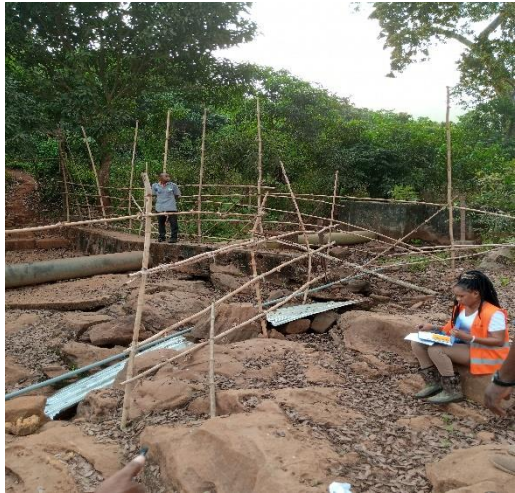
<p>Broken fence and low water level</p>

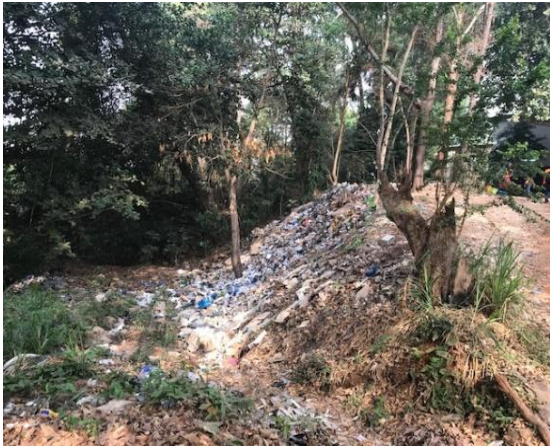
<p>Waste-dump at catchment</p>

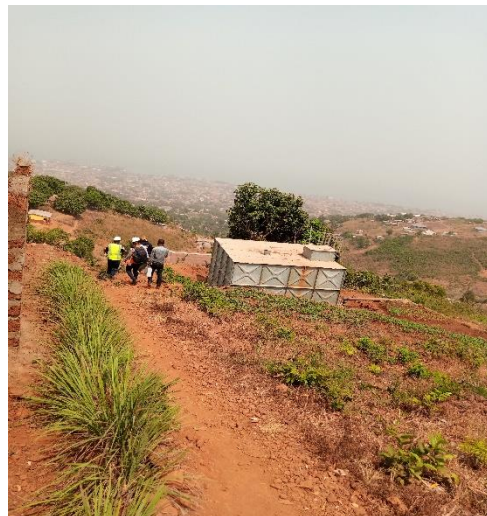
<p>Catchment area highly deforested</p>

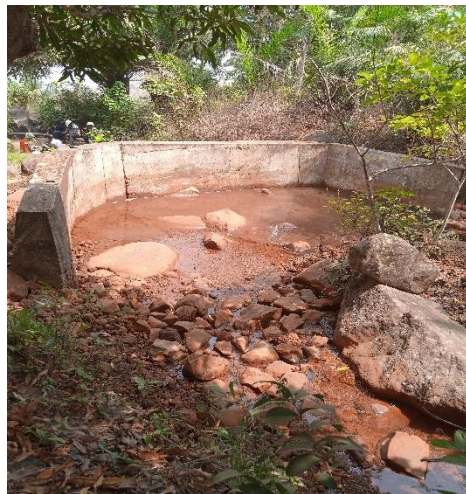
<p>Dry reinforced concrete weir.</p>
---	--------------	------------------------	--	---

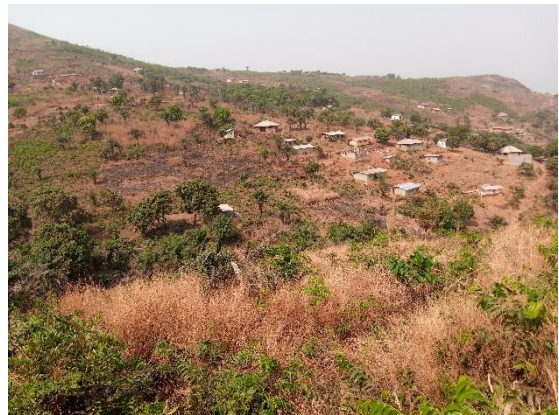
<p>Massive encroachment around catchment</p>

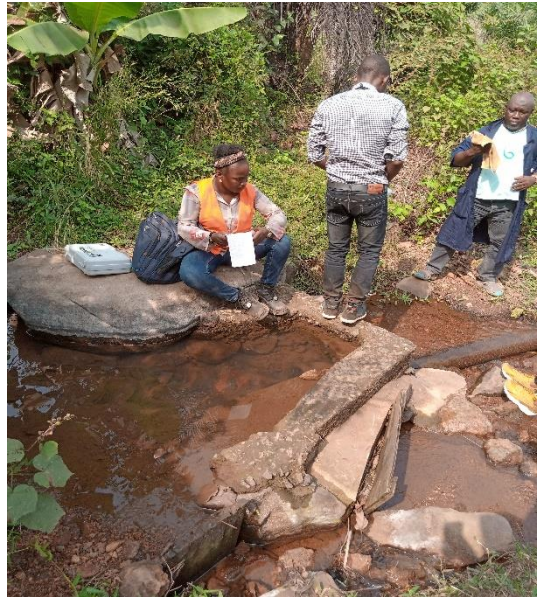
<p>Undersized weir with leakages around</p>
---	-----------	----------------------	--	---

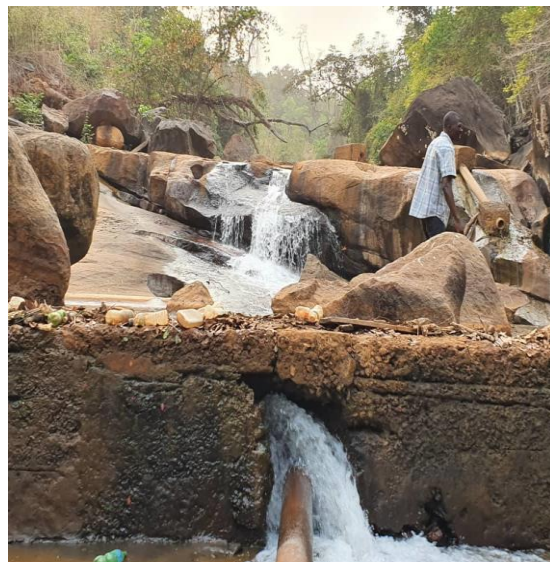
<p>Massive leakage in reinforced concrete weir</p>

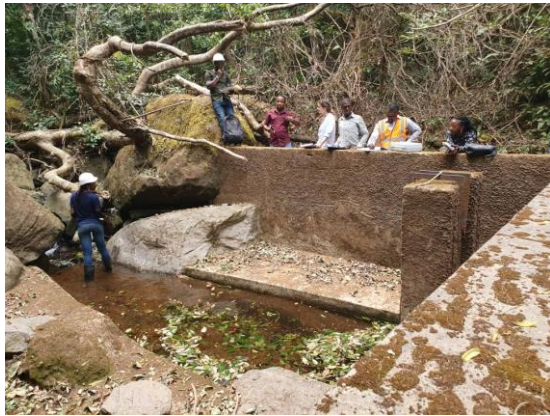
<p>Dry weir with surrounding seepage.</p>

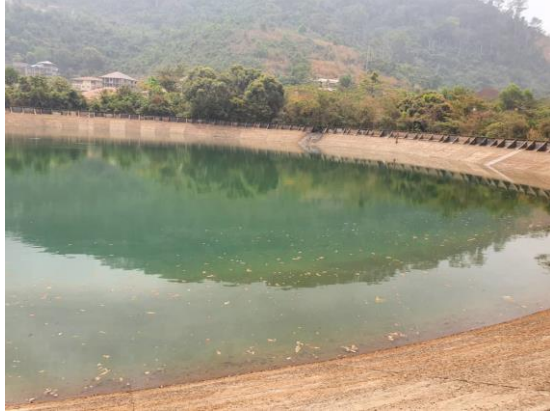
Babadorie Reservoir getting dry

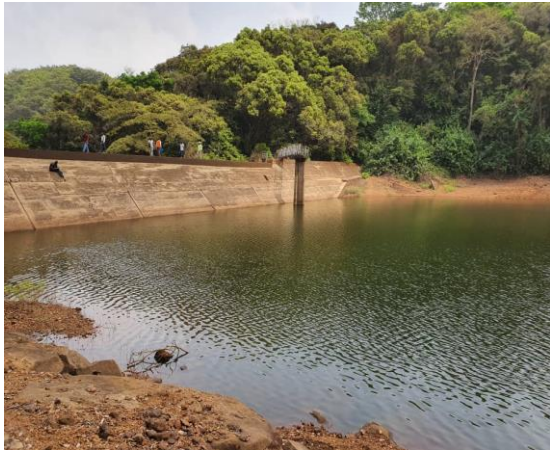
Low water level in the reinforced concrete Kongo Dam

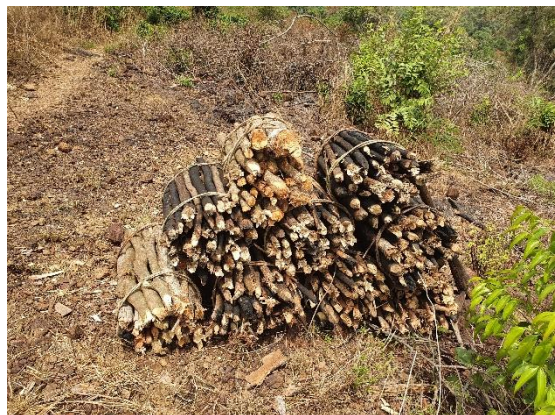
<p>Firewood harvesting</p>

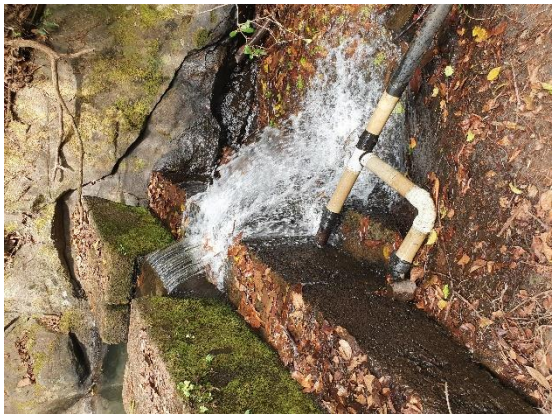
<p>Massive leakage and overflow over intake pipe</p>
---	------	---	--

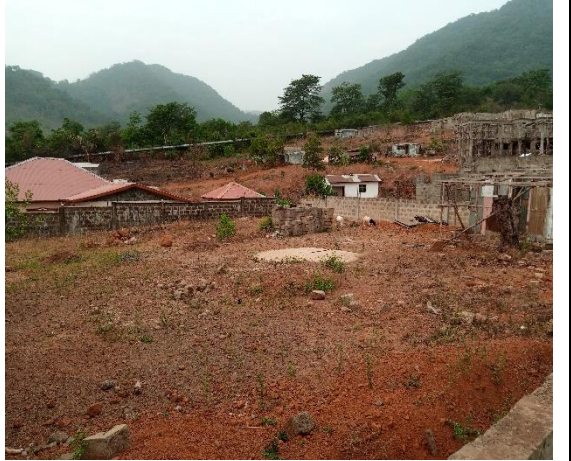
<p>Construction activities at lower catchment areas</p>

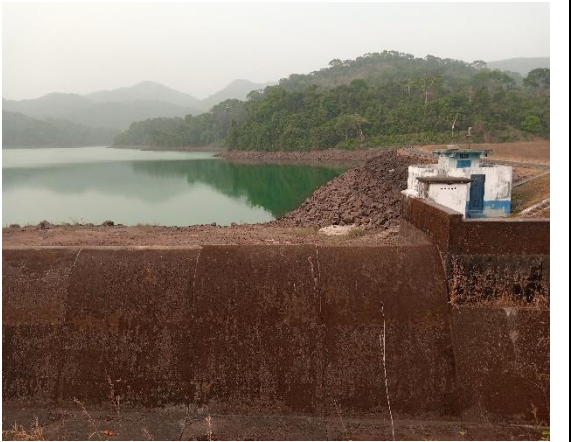
<p>Low water level in dam</p>

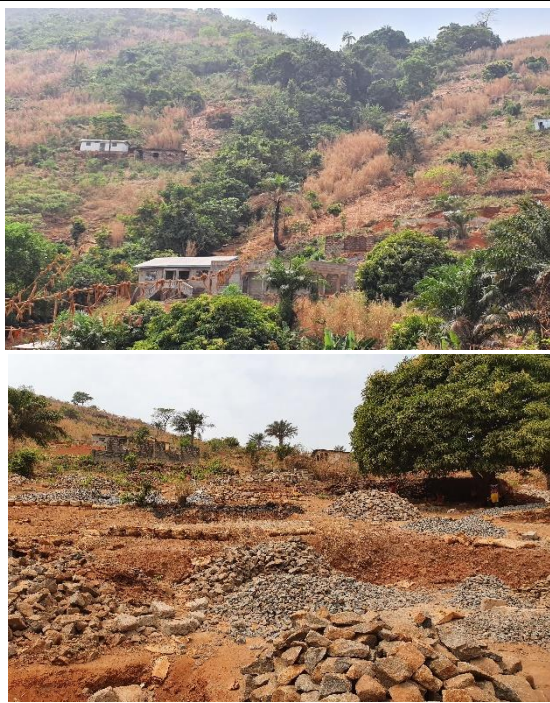
<p>Highly deforested and stone mining activities</p>
10	Lower Faiamambo	<p>Type of source(s) and Construction and management body Spring, it flows from the hills. It was constructed in 1986 and rehabilitated in 2014 by SALWACO and is being managed by WARDC</p> <p>Land ownership and % of Depletion. 70 % of the catchment is depleted and some of the catchment lands are owned by NASSIT whiles the remaining is owned by the community people.</p>

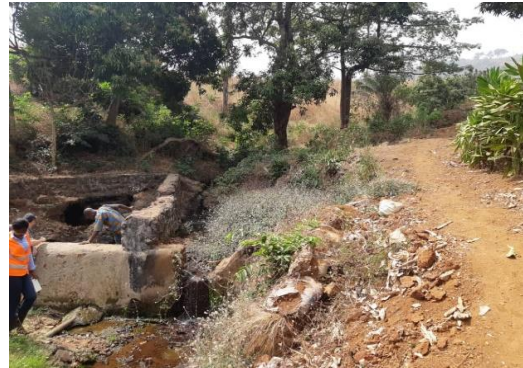
<p>Deforestation and construction activities</p>

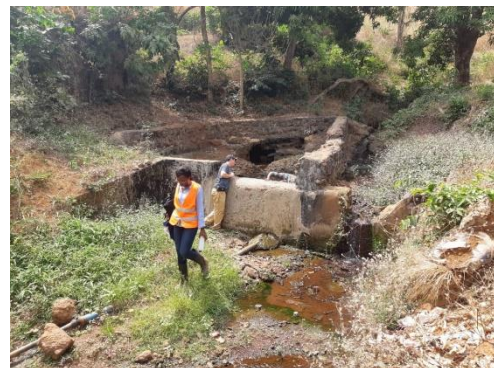
<p>Dilapidated weir with insufficient water</p>
11	Upper Faiamambo	<p>Type of source(s) and Construction and management body Spring, it flows from underneath the rocks. It was constructed in 1986 and rehabilitated in 2014 by SALWACO and is being poorly managed by WARDC</p> <p>Land ownership and % of Depletion. 70 % of the catchment is depleted and some of the catchment lands are owned by NASSIT whiles the remaining is owned by the community people.</p> <p>Activities undertaken in the catchment area Stone mining, construction of dwelling houses and firewood harvesting</p> <p>Intake structure (if any and water supply areas Reinforced concrete weir and chamber and is completely roofed to reduce the evaporation rate. Water from this weir is being pumped into the spherical reinforced concrete reservoir. Currently, there is insufficient water in the weir due to the depleted catchment. It was designed to supply to upper faiamambo, proposed NASSIT estate, council area down to the market and the surrounding</p>

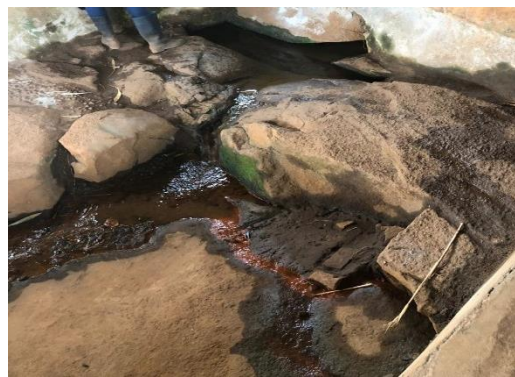
<p>Insufficient water in the protected weir.</p>

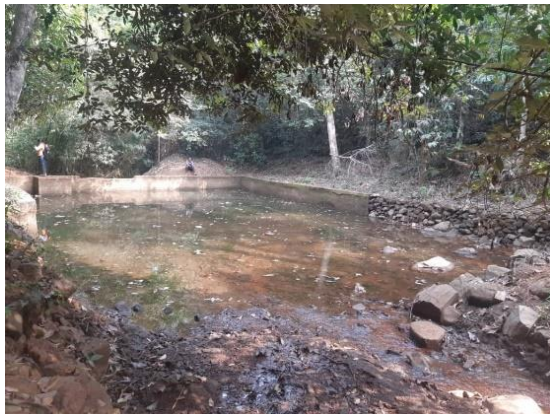
<p>Well managed catchment with sufficient water</p>

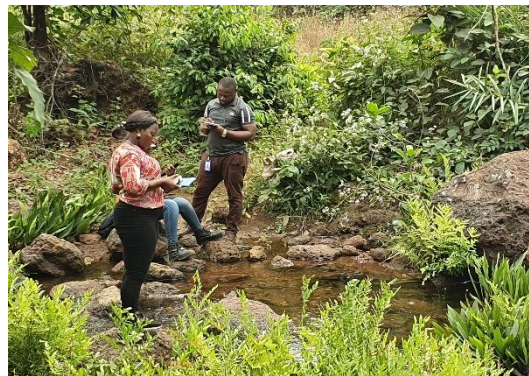
<p>Potential and viable stream source</p>

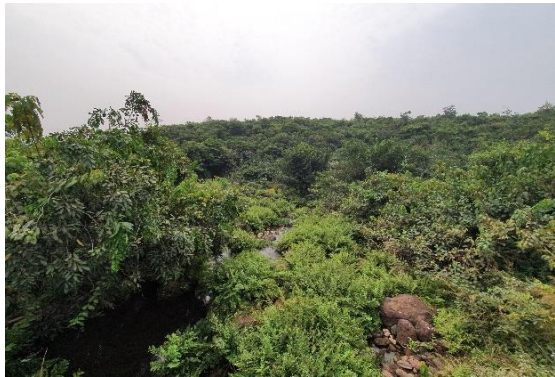
<p>Two to three tributaries joining the main stream, moderately deforested.</p>
----	----------	---	--

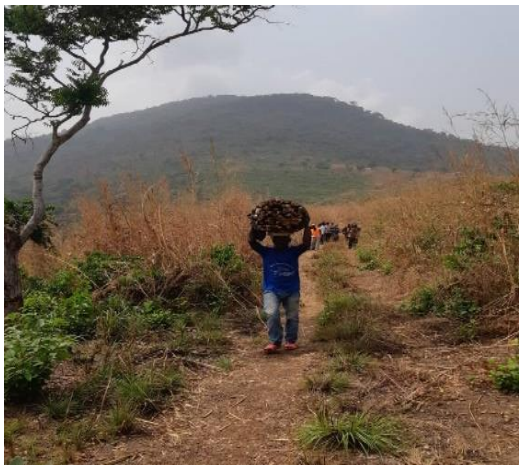
<p>Farming, firewood and charcoal burning</p>

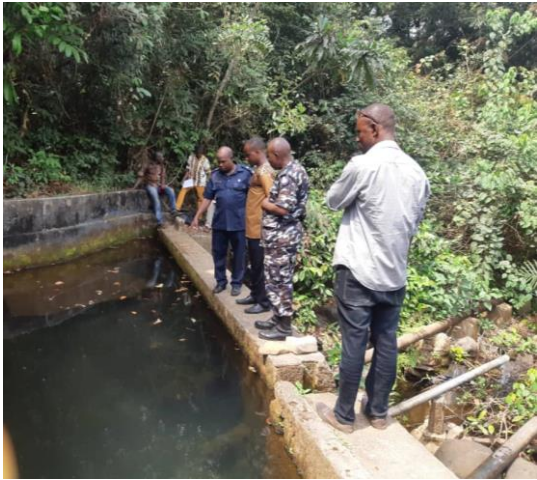
<p>Good source with moderate water level</p>
----	---	---	---

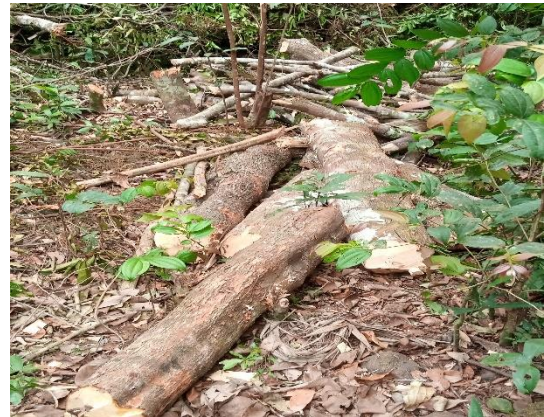
<p>Intensive logging and deforestation</p>

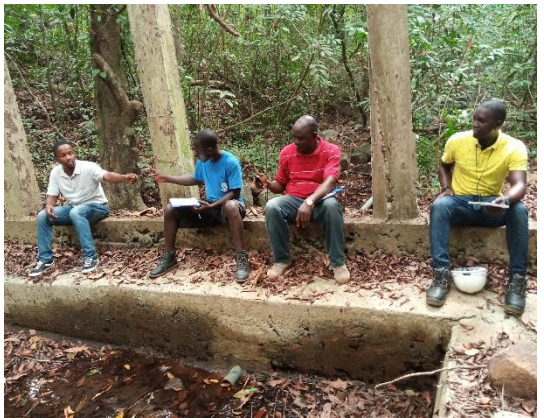
<p>Empty weir with tree debris and siltation</p>
----	--------	---	--

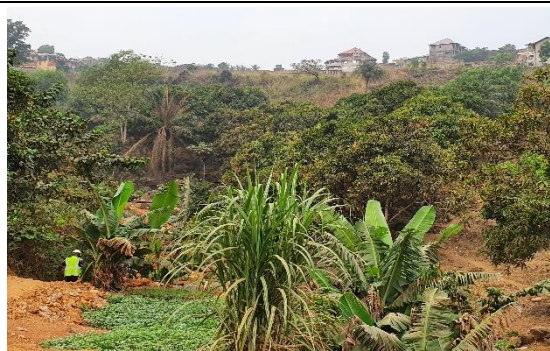
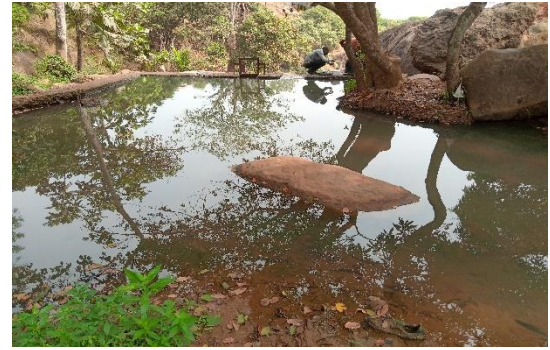
<p>Gardening and construction activities (top), High water level with undersized weir (bottom)</p>
17	Kaningo	<p>Type of source(s) Construction and management body Spring flows from underneath rocks. It was constructed and managed by the Community. GVWC have plans to construct a spring box at the source.</p> <p>Land ownership and % of Depletion. 100 % of the catchment is depleted and the land where the catchment is situated is being converted into private lands.</p> <p>Activities undertaken in the catchment area Gardening, laundry, massive stone mining and construction of dwelling houses.</p>

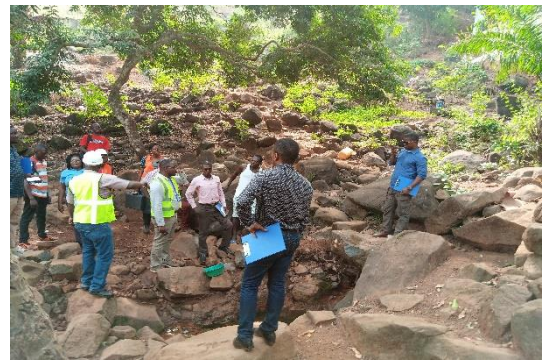
<p>Deforestation and stone mining activities</p>

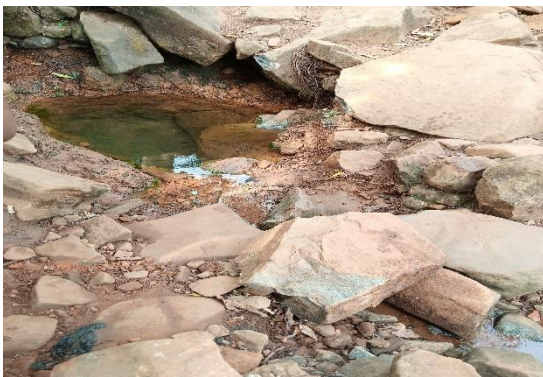
<p>Depleted spring source</p>
18	John Obey		<p>Type of source(s) Construction and management body</p> <p>Spring flows from the forest upstream. It was constructed by a philanthropist and currently managed by the community people</p> <p>Land ownership and % of Depletion.</p> <p>70 % of the catchment is depleted and the land where the catchment is situated is owned by private people.</p> <p>Activities undertaken in the catchment area</p> <p>Stone mining, construction of dwelling houses and logging.</p> <p>Intake structure (if any and water supply areas)</p> <p>The weir is poorly constructed and 60% of the water that flows is being wasted through seepage. The source is supplying water to John Obey community and the surrounding smaller communities with a population of over 12,000.</p>

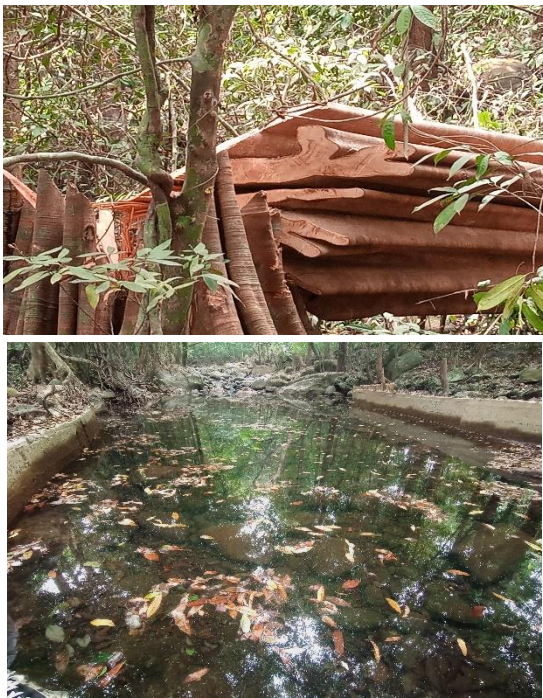
<p>Intensive logging activity (top) Low water level in weir (bottom)</p>

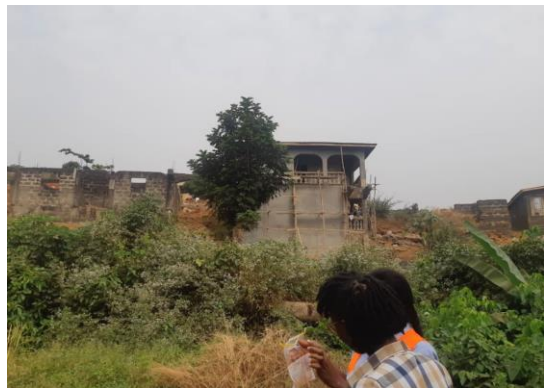
<p>Stone mining, construction of dwelling houses logging and farming activities.</p>

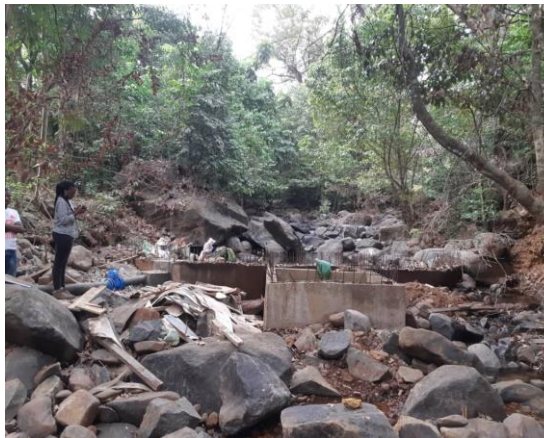
<p>Weir poorly constructed with seepage underneath.</p>

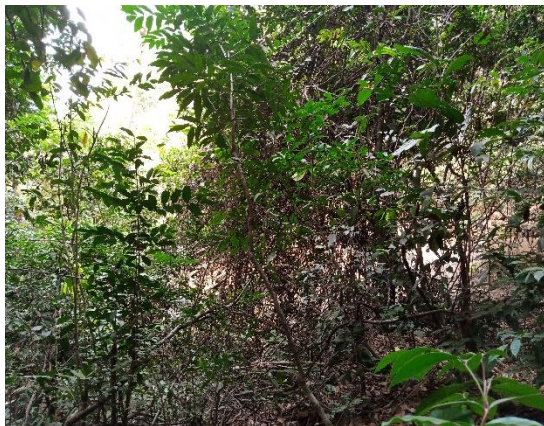
<p>Bush clearing and coal burning activities</p>

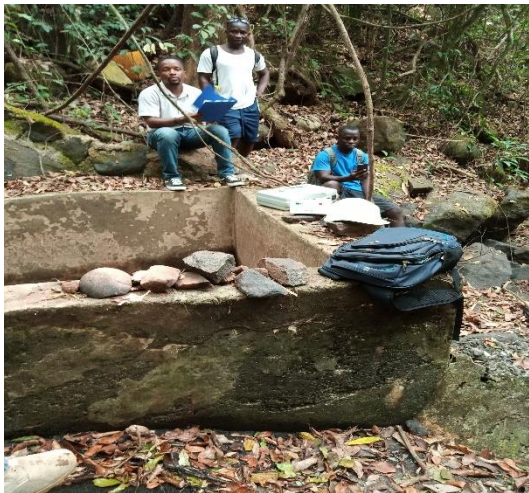
<p>Poorly designed and empty weir</p>

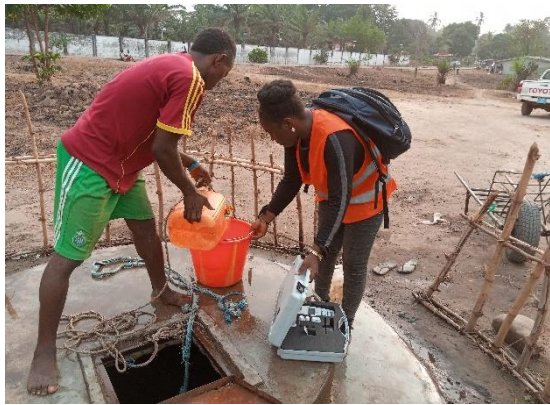
<p>Community hand-dug well</p>
22	Kerry town		<p>Type of source(s) Construction and management body.</p> <p>The community relies on wells as they don't have a gravity source on their own. There is a gravity potential if developed can serve the town and the areas that host the Ambulances and other medical facilities.</p> <p>Land ownership and % of Depletion.</p> <p>Currently, 30 % of the catchment is depleted and the land is allegedly owned by the government and community people.</p> <p>Activities undertaken in the catchment area</p> <p>Stone mining, construction of logging, farming and coal burning.</p> <p>Intake structure (if any and water supply areas)</p> <p>There is no intake structure but if developed can serve waterloo and its surrounding communities with a population of over 15,000 people.</p>

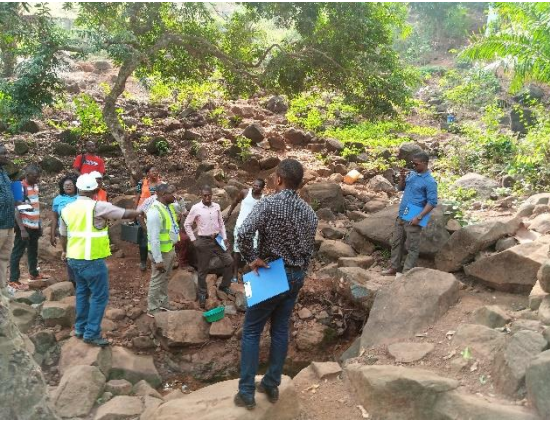
<p>Stone mining and farming activities</p>

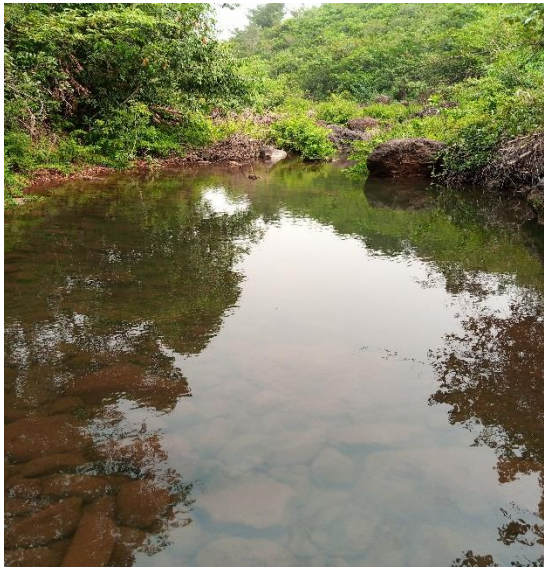
<p>Potential and viable source</p>
24	Hastings Orgbonokie	<p>Type of source(s) Construction and management body Spring flows from the hills overlooking the other side of Hastings and Kosso town.</p> <p>Land ownership and % of Depletion. Currently, 30 % of the catchment is depleted and the land is allegedly owned by the government and the two communities.</p> <p>Activities undertaken in the catchment area Stone mining, construction of dwelling houses downstream, logging, farming and coal burning.</p> <p>Intake structure (if any and water supply areas) Weir constructed but there is seepage causing about 30% of the inflow to be wasted. It is supplying some parts of Hastings village, Hastings new site and the</p>

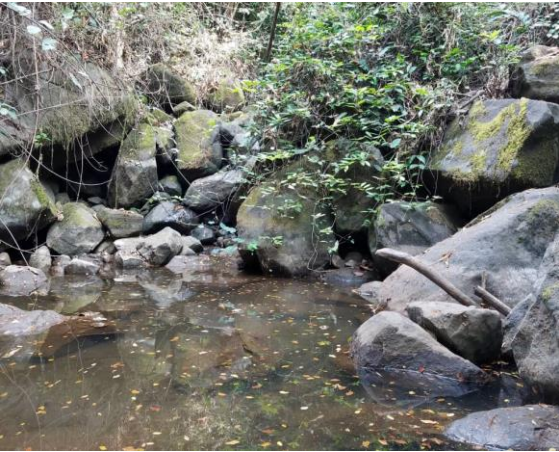
<p>Viable spring source with approximately 30% deforested.</p>

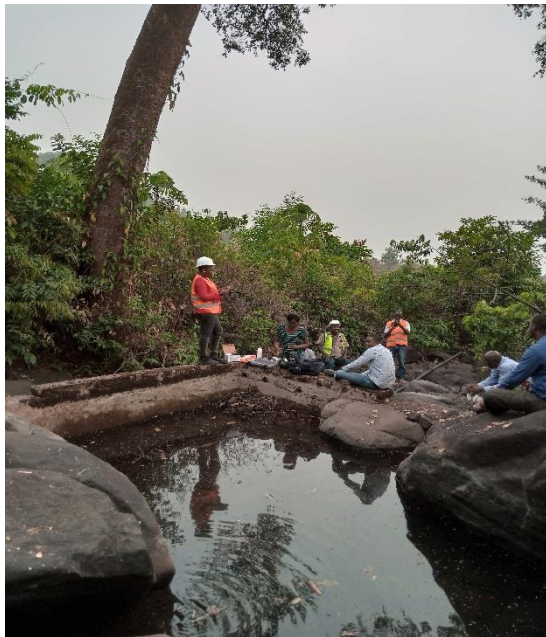
Clean spring source

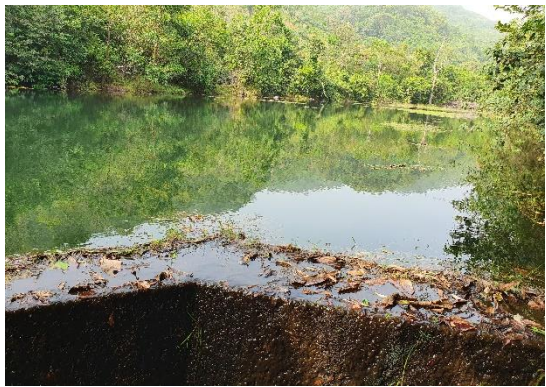
<p>Weir No. 1 with high gravity potential and high water level managed by "The Place Hotel"</p>

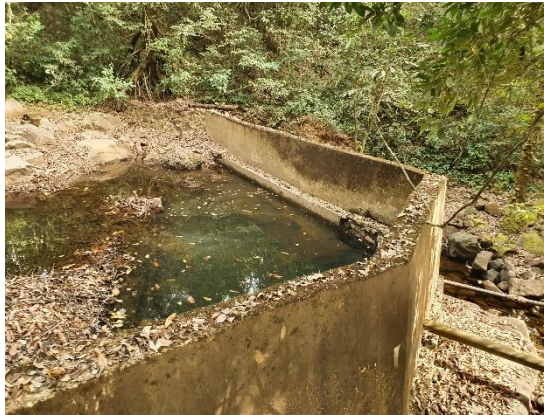
<p>Weir No. 2 (Africana) with low gravity potential and low water level managed by the community.</p>

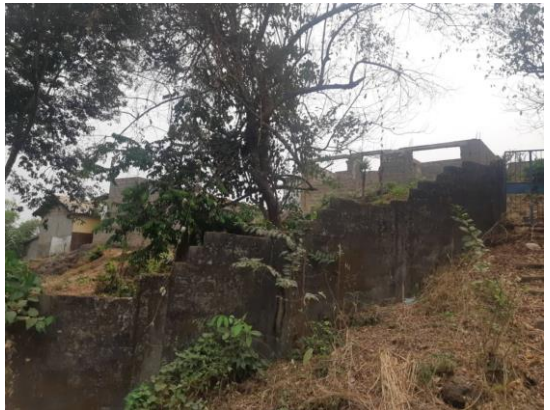
<p>Highly depleted and encroached catchment</p>

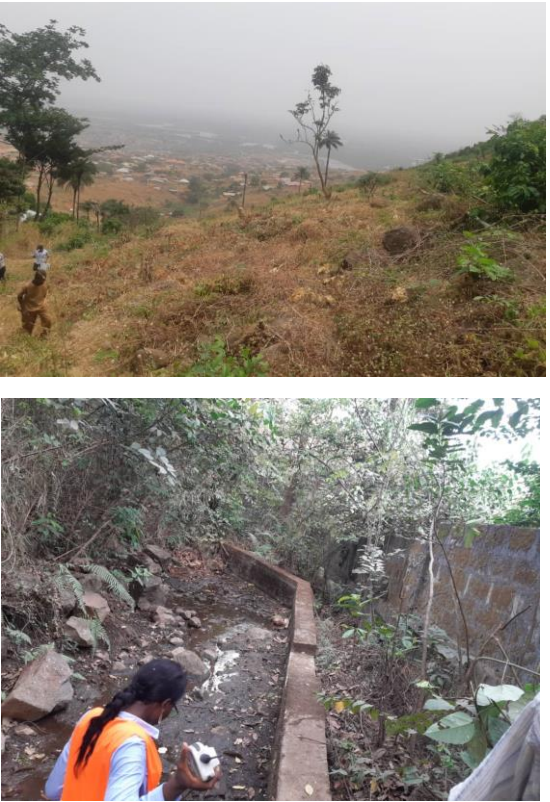
<p>Intense deforestation (top) with a completely dried weir (bottom).</p>
----	---------------------	--	---

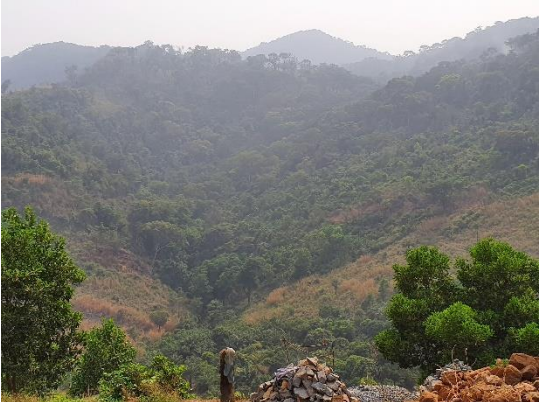
<p>Stone mining and deforestation activities within catchment.</p>

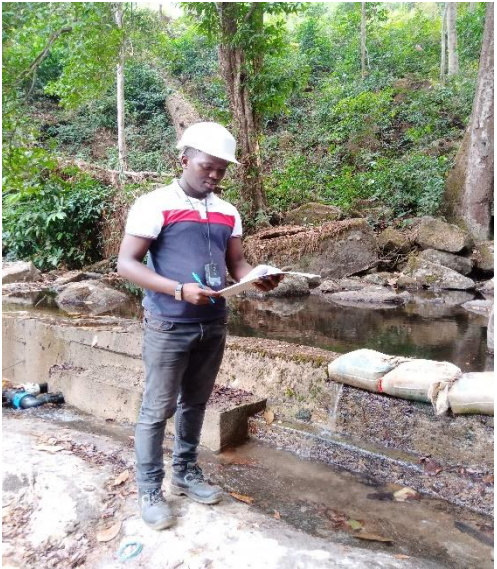
<p>Low capacity stream weir</p>

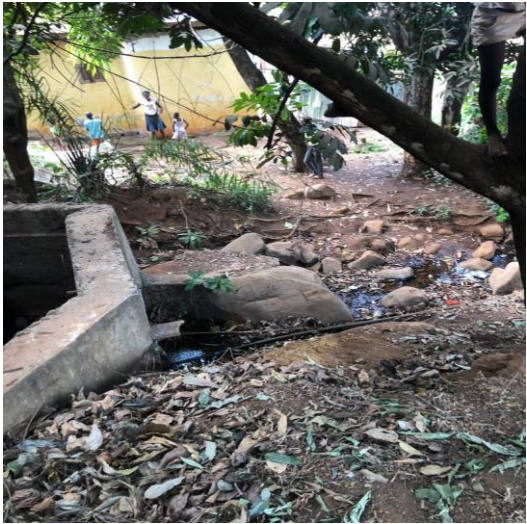
<p>Massive encroachment</p>

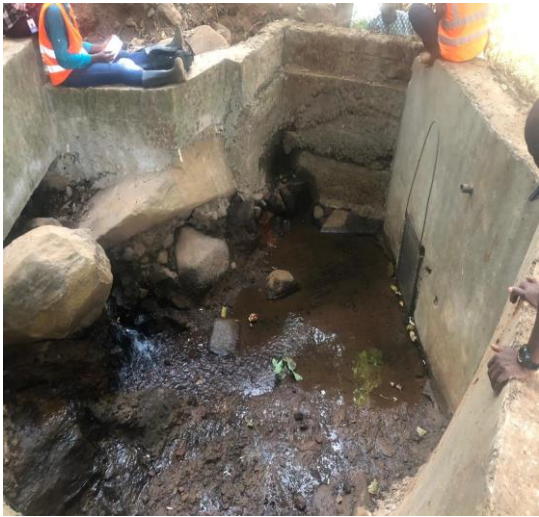
<p>Weir being dried out</p>

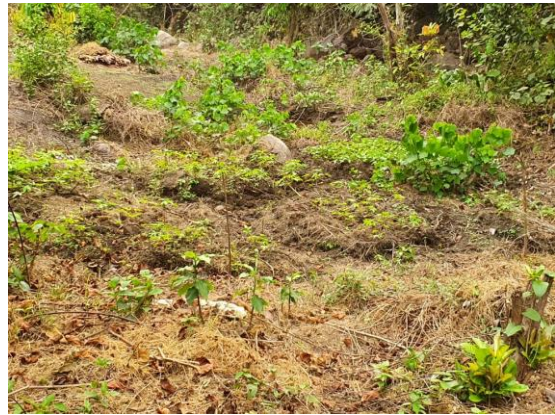
<p>Bush clearing and deforestation</p>

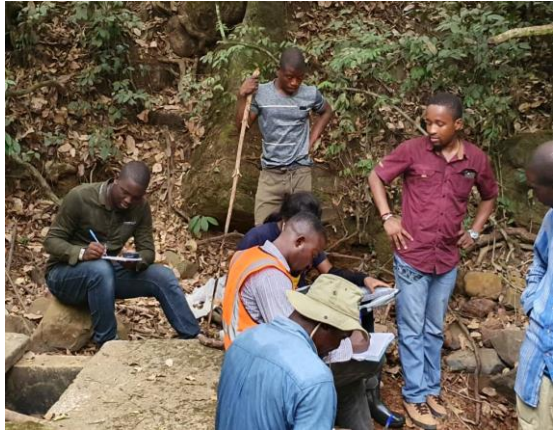
<p>Weir does not retain water due to high seepage</p>

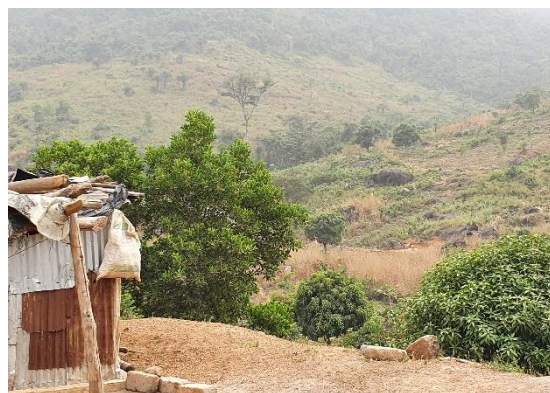
<p>Coal burning and dwelling construction.</p>

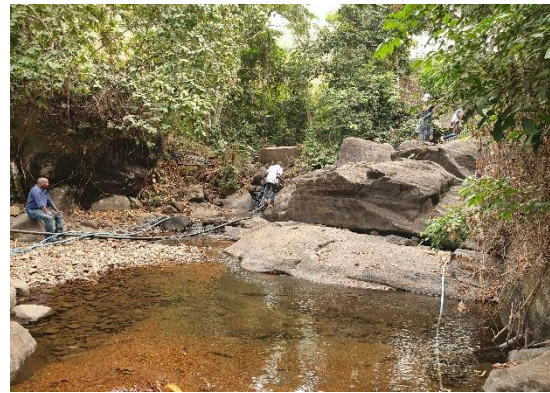
<p>Catchment under massive deforestation threat</p>

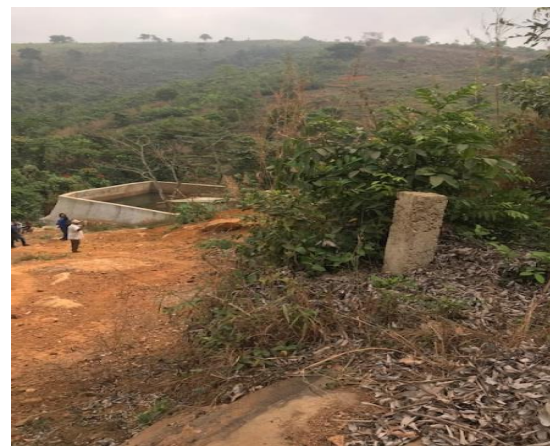
<p>Weir 1 with high gravity potential and concrete peg demarcating private land ownership.</p>

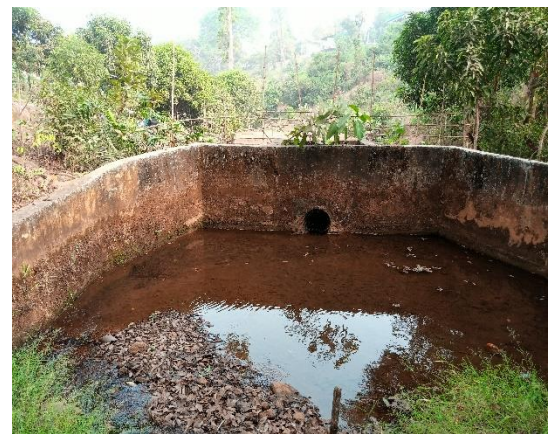
<p>Weir 2 with low water level and seepage</p>

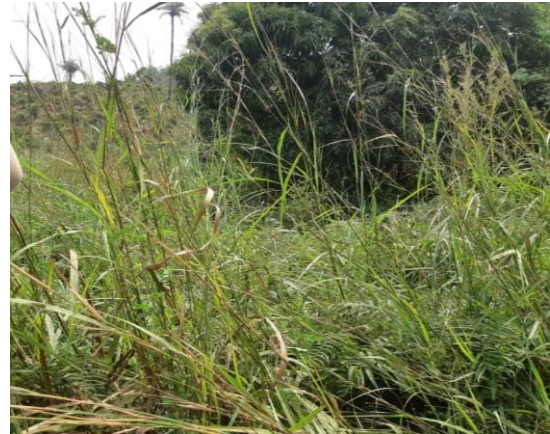
<p>Bush clearing and deforestation</p>

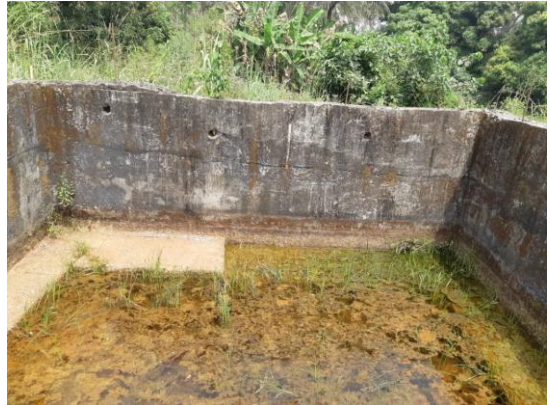
<p>Spring box getting dried</p>
----	------------	---	--	---

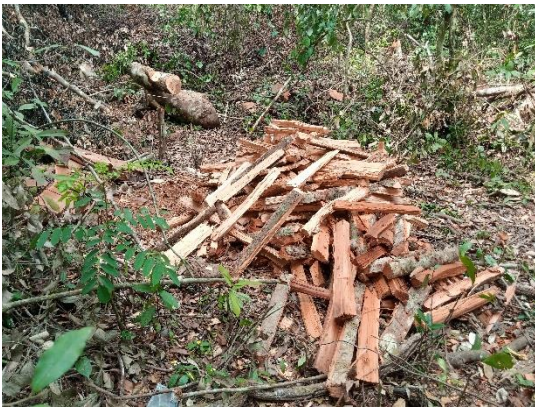
<p>Coal burning and firewood harvesting</p>

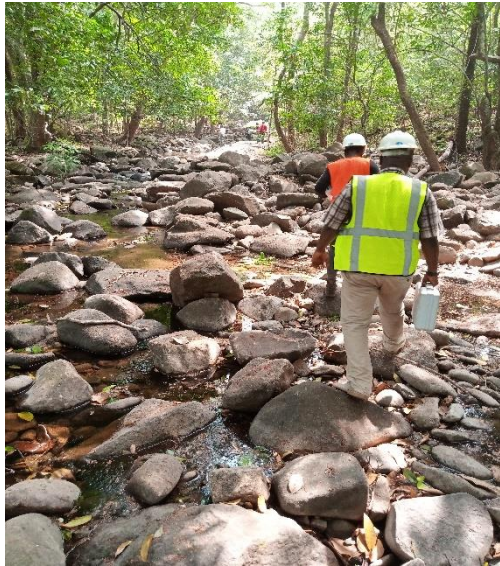
<p>Low water level in stream</p>
----	-----------	---------------------	--	---

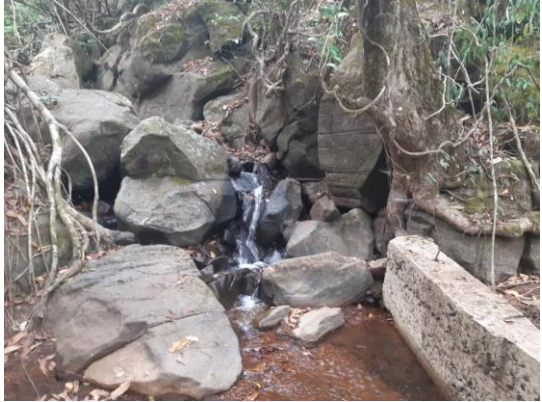
<p>Spring source from hill with stone mining and deforestation</p>

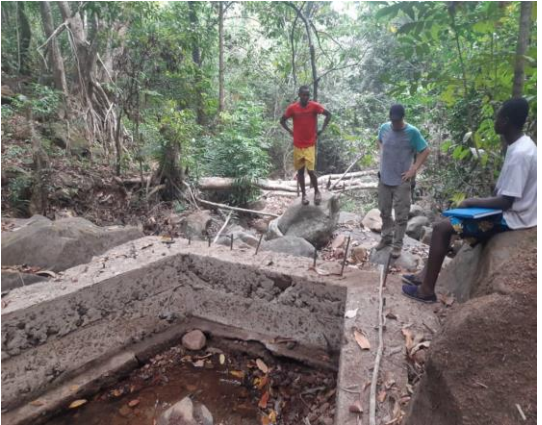
<p>Weir in very bad condition with insufficient water</p>
----	--------	--	---

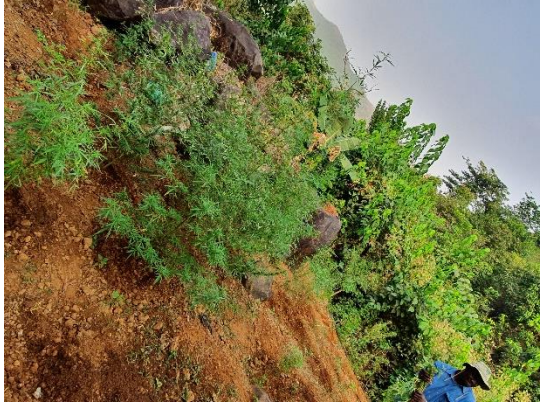
<p>Deforestation and marijuana farming</p>

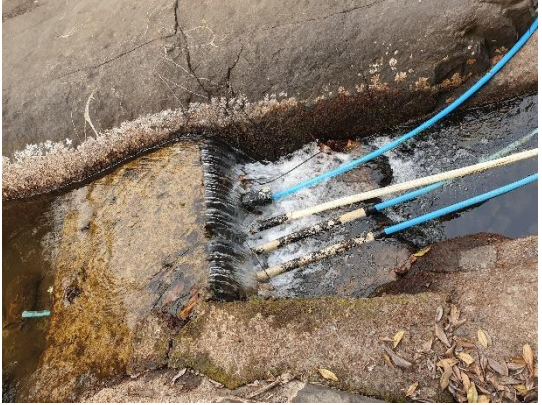
<p>Weir with private pipe connections.</p>
----	--------	--	--

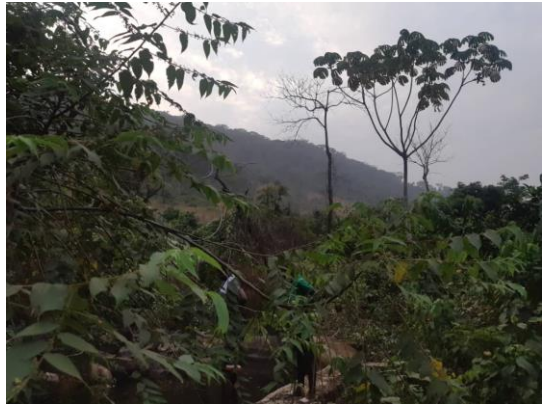
<p>Stone mining, burning and firewood harvesting.</p>

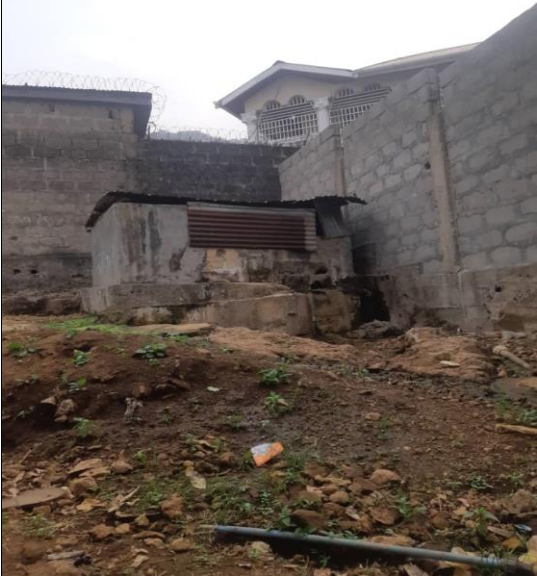
<p>Construction of dwelling houses within catchment</p>
----	-------------	--	--
