# PHILIPPINES

## Salvage to Build Back Better

## PROJECT DESCRIPTION

## What did CRS do?

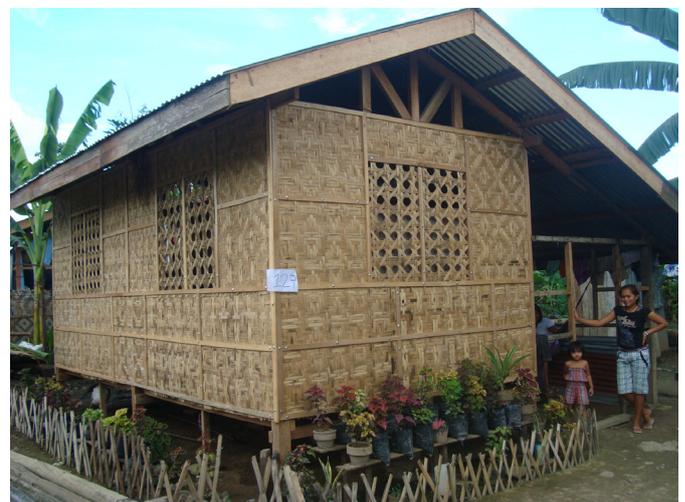
A finished shelter. Three pilot models were built to elicit participant feedback.  
Photo: Seki Hirano / CRS

CRS's senior technical advisor, in collaboration with engineering staff, developed three pilot models, all of which used locally available materials, and enhanced local construction knowledge. CRS held community feedback sessions to select the preferred model.
