MADAGASCAR

Remote Programming for Resilient Homes

PROJECT DESCRIPTION

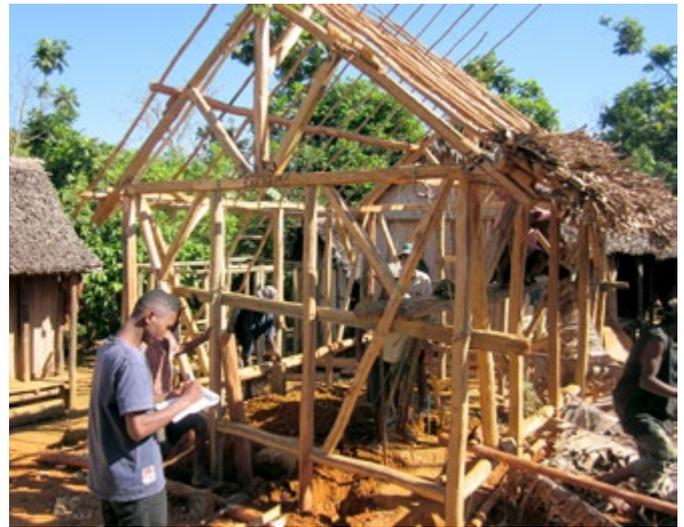
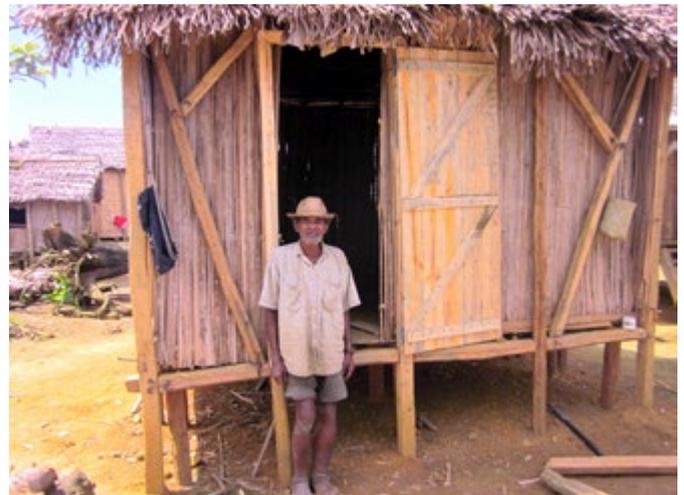
House under construction (top) and completed (bottom). The project used remote management through community committees to build 598 houses in difficult to access villages and conduct trainings.

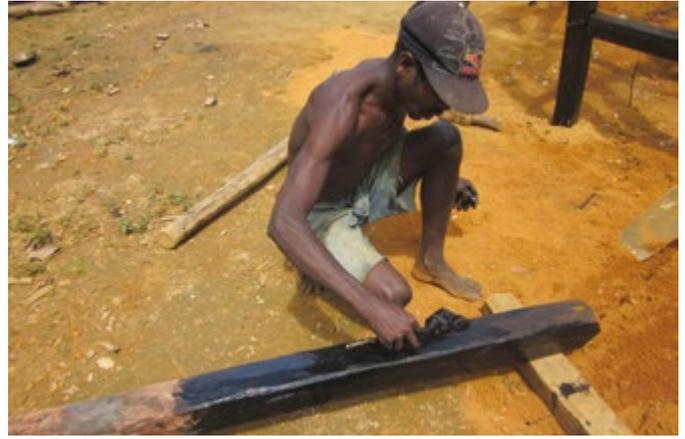
Structural members are treated with used engine oil, or similar to preserve and to prevent termite infestation.
Photo credit: J.E. Andrianambinina / CRS

3. Is the wood dry?
4. Is oil used to preserve the wood?
5. Have you buried the footing 10 cm deep?
6. Have you used broken rocks before burying the foundation and columns?
7. Are corner bracings at the floor platform connection present?

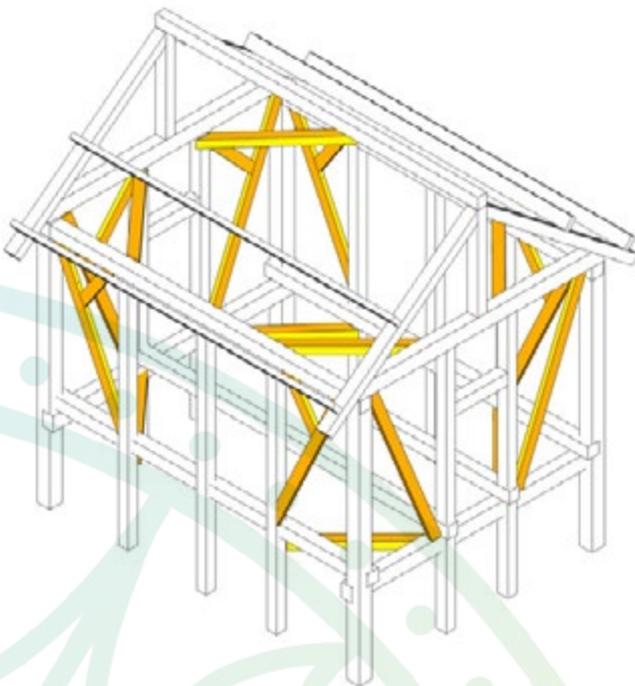
Axonometric 3D diagram showing improved structural components to houses.
Credit: Amanda Rashid / CRS

8. Diagonal bracings used at four corner columns
9. Diagonal smaller corner bracings used at corners to connect the diagonal bracings
10. All column connections with beam used appropriate parts and not nails
11. All connections with beams and columns using metal straps and nails

12. Corner bracings used at all corners
13. Metal straps are used to connect the Truss/Triangle with beam
14. All connections between members made with mortise and tenon joints
15. Diagonal technique used to connect the ridge with truss
16. Four corners of beams has corner bracings
