# PHILIPPINES

## Salvage to Build Back Better

## PROJECT DESCRIPTION

**Disaster:** Typhoon Bopha (Pablo)

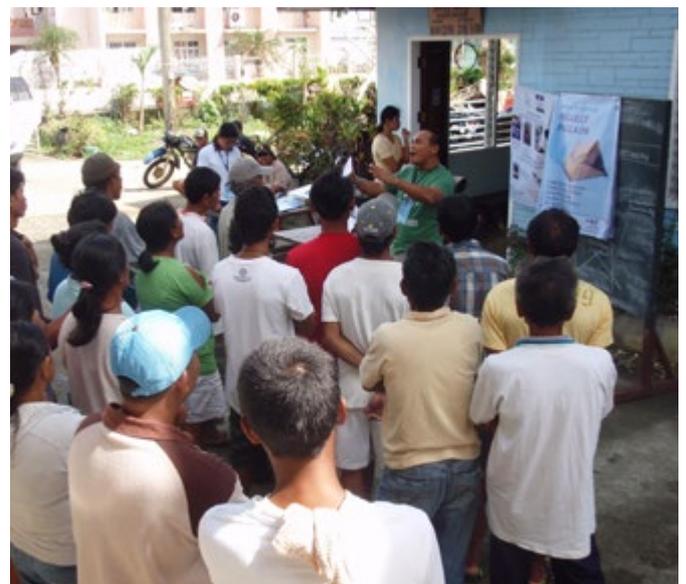
Families are introduced to the shelter design which was developed after studying local techniques.

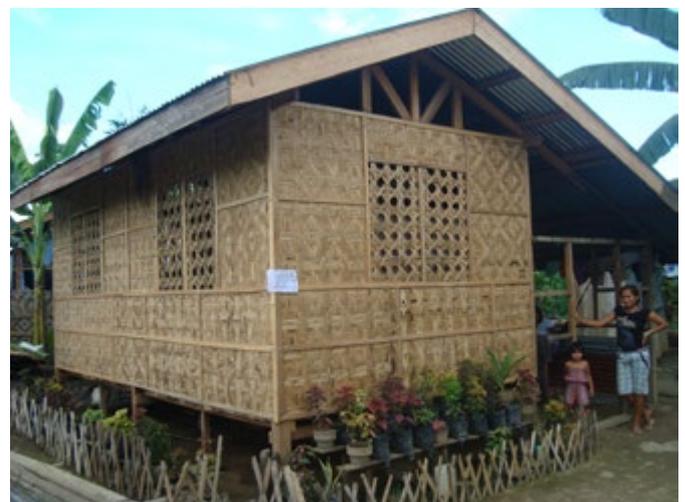
A finished shelter. Three pilot models were built to elicit participant feedback.  
Photo: Seki Hirano / CRS

CRS's senior technical advisor, in collaboration with engineering staff, developed three pilot models, all of which used locally available materials, and enhanced local construction knowledge. CRS held community feedback sessions to select the preferred model.

Five disaster-resilient construction techniques were incorporated in the shelter design:

- **Reinforcement of key structural joints:** Connections between wooden pillars, beams, trusses, roof purlins, and bracing were reinforced with metal strapping.
- **Lateral bracing:** Cross- or corner-bracing was applied to increase the frame's resistance to lateral forces.
- **Firm anchoring of roofing sheets:** Sheets were held in place using fasteners such as J-hooks or bolts.
- **Raised floor:** Shelters were constructed above typical flood levels.
- **Foundations:** Frames were built upon, and anchored to, concrete or stone foundations buried 50cm-100cm below ground, to prevent both uplift during storms and subsidence.
