REPORT ON STAKEHOLDER ASSESSMENT OF THE WESTERN AREA WATER CATCHMENT AREAS

National Water Resources Management Agency (NWRMA)

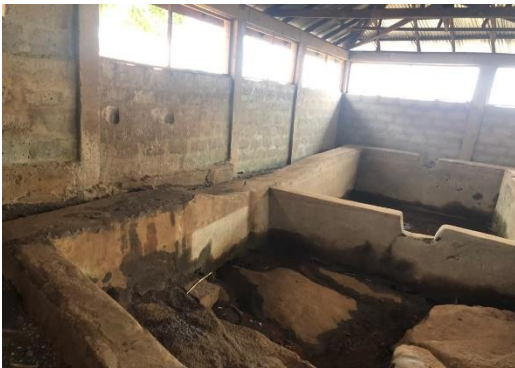
<p>Insufficient water in the protected weir.</p>

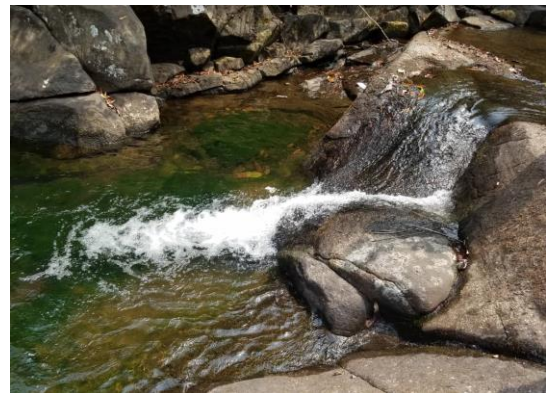
<p>Viable spring source with approximately 30% deforested.</p>

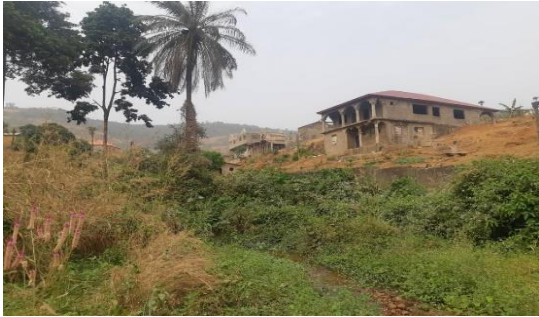
<p>Intense deforestation</p>

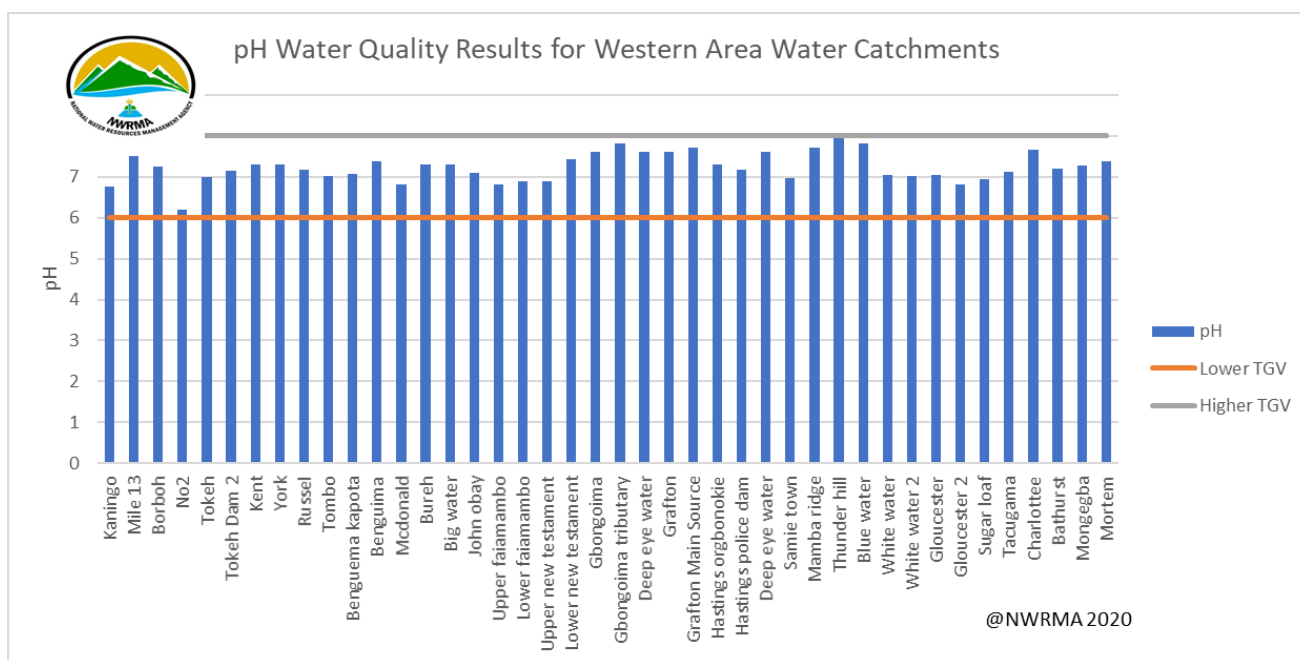
Figure 1: pH results of western area water sources

With regards pH, all results of the water sources fall within the permissible limits of 6 to 8 as shown in the figure below.

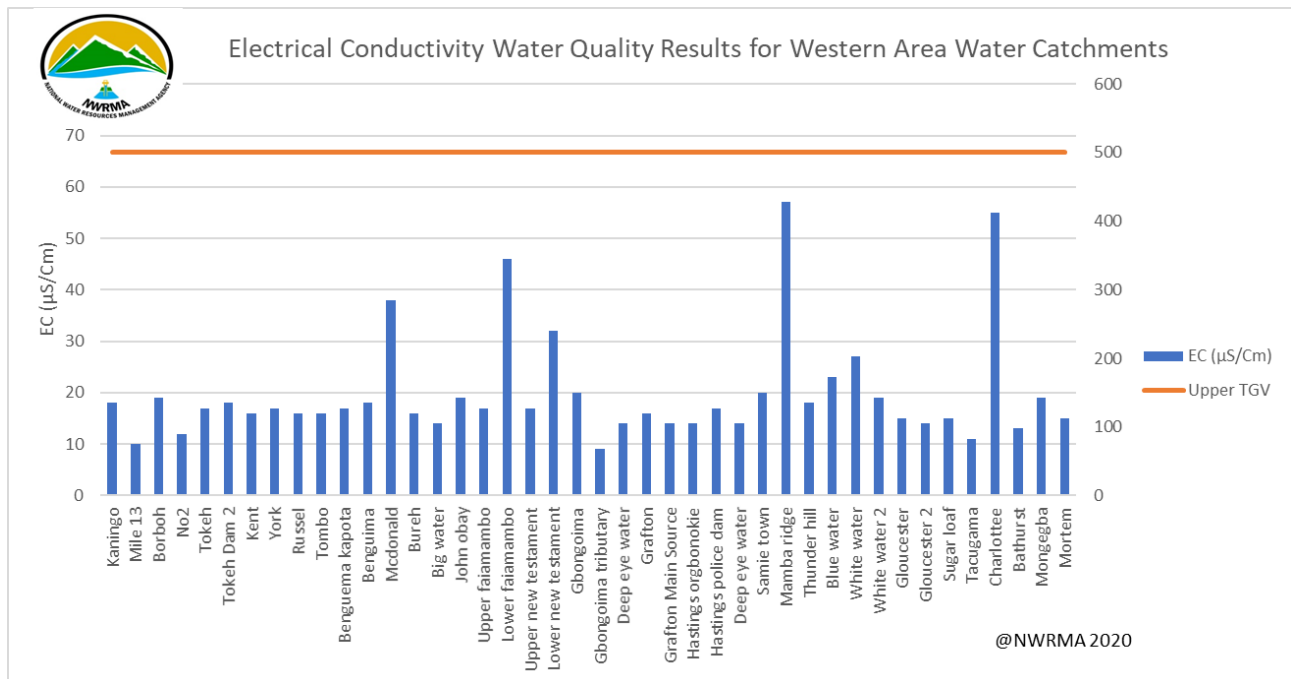
Figure 2: Electrical conductivity results for the western area

In addition, all the water sources result for electrical conductivity are below the upper limit of 500 ($\mu\text{S}/\text{Cm}$) as shown in the figure below.

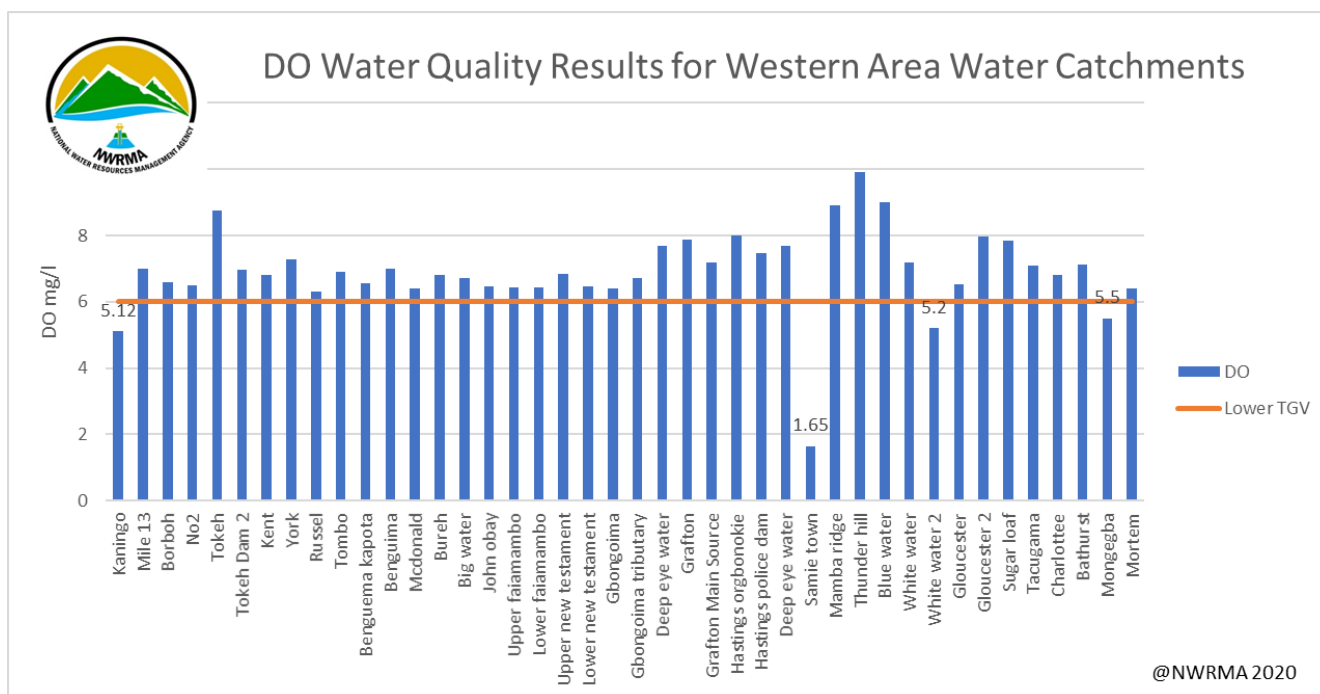
Figure 3: DO results for water sources in the western area catchments

Furthermore, most of the water sources have Dissolve Oxygen values that are above the lower target values with the exception of Kaningo, Samie town, White water 2 and Mongegba.

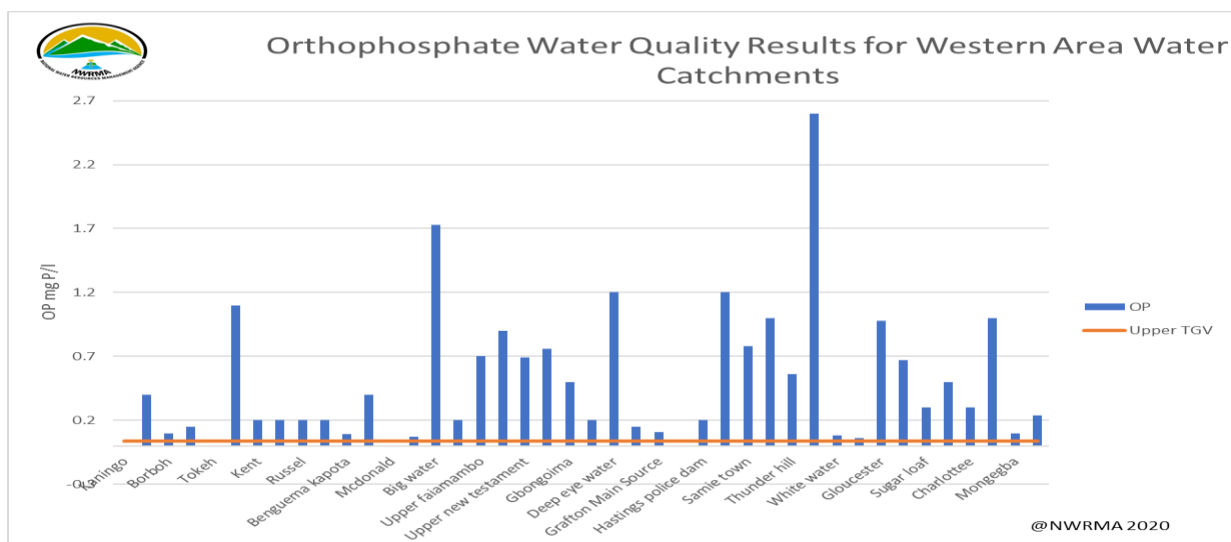
Figure 4: Orthophosphate results for water sources in the Western Area

On the other hand, all of the water sources at the catchments do not meet values above the minimum Orthophosphate values as shown in the figure below.

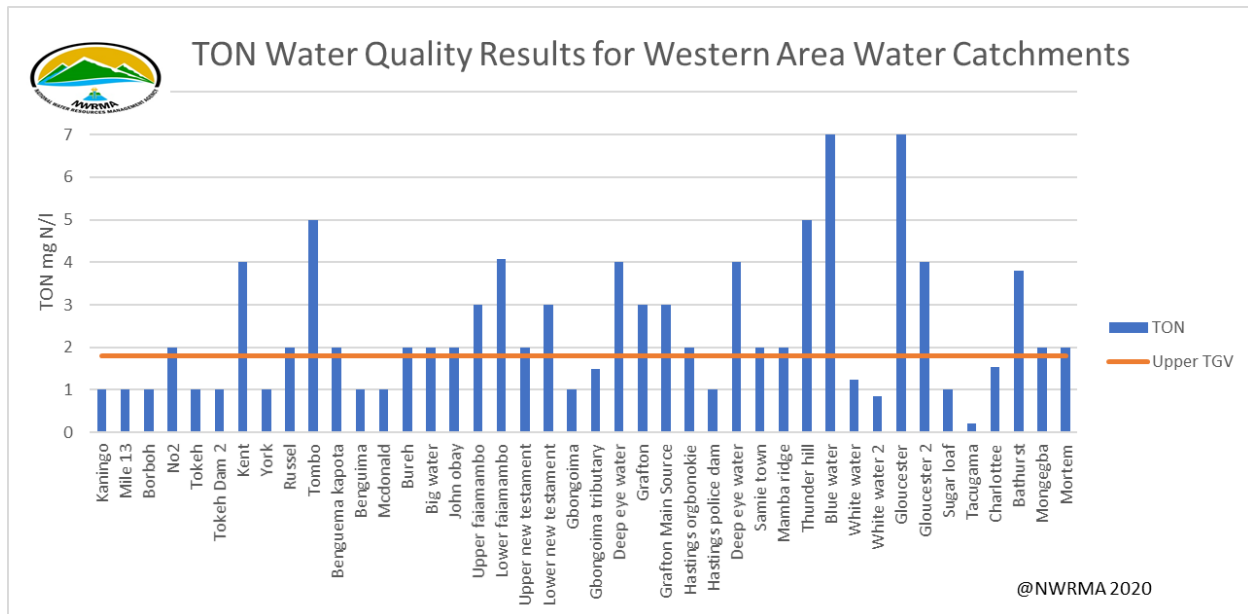
Figure 5: TON results for water sources in the western area catchment.

Furthermore, many water sources have values that are higher than the permissible limit for TON as shown in the figure below.
