MADAGASCAR Remote Programming for Resilient Homes

HUMANITARIAN RESPONSE CASE STUDY 12

CATHOLIC RELIEF SERVICE

Disaster: Intense Tropical Cyclone Giovanna and moderate Tropical Storm Irina

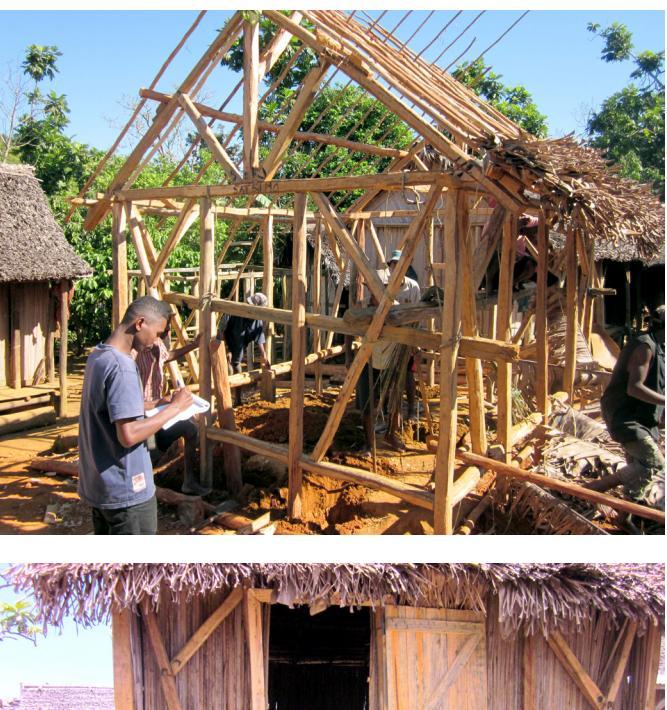
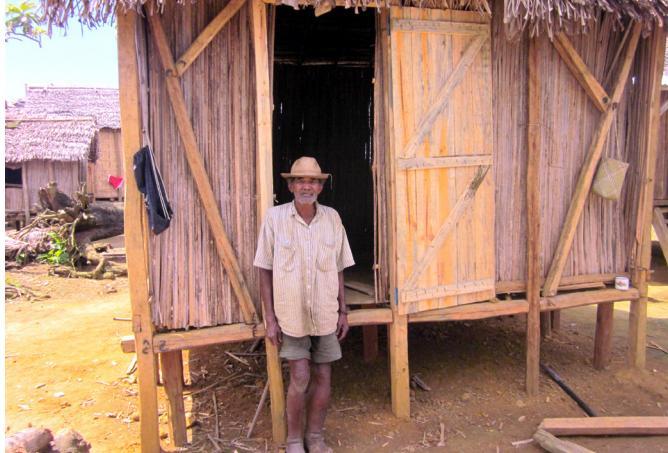
House under construction (top) and completed (bottom). The project used remote management through community committees to build 599 houses in difficult to access villages and conduct trainings. Photo: J.E. Andrianambinina / CRS

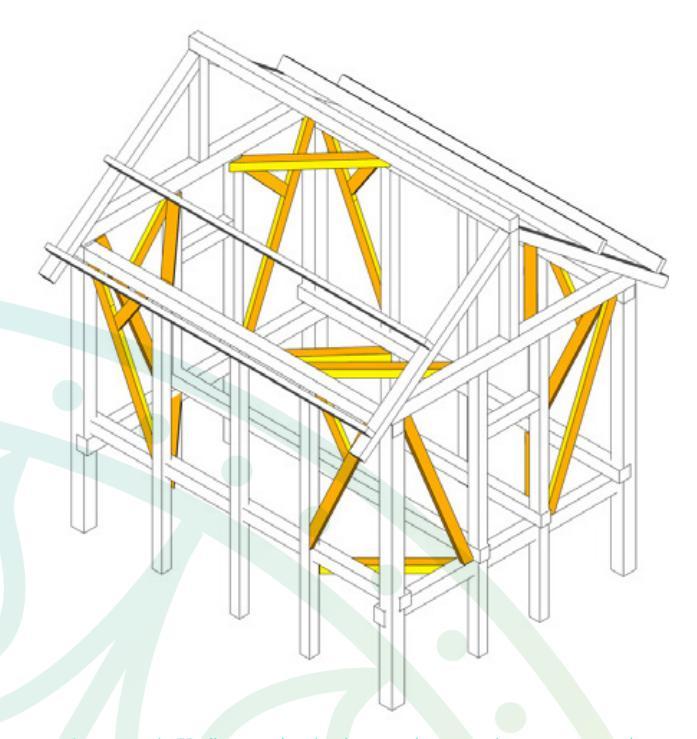
Axonometric 3D diagram showing improved structural components to houses. Credit: Amanda Rashid / CRS

- 8. Diagonal bracings used at four corner columns
- 9. Diagonal smaller corner bracings used at corners to connect the diagonal bracings
- 10. All column connections with beam used appropriate parts and not nails
- 11. All connections with beams and columns using metal straps and nails

- 12. Corner bracings used at all corners
- 13. Metal straps are used to connect the Truss/Triangle with beam
- 14. All connections between members made with mortise and tenon joints
- 15. Diagonal technique used to connect the ridge with truss
- 16. Four corners of beams has corner bracings

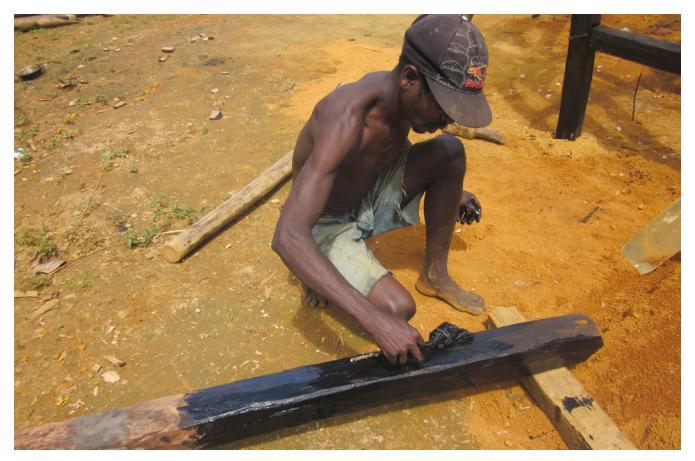
Structural members are treated with used engine oil, or similar to preserve and to prevent termite infestation. Photo credit: J.E. Andrianambinina / CRS

- 3. Is the wood dry?
- 4. Is oil used to preserve the wood?
- 5. Have you buried the footing 10 cm deep?
- 6. Have you used broken rocks before burying the foundation and columns?
- 7. Are corner bracings at the floor platform connection present?

- 17. Metal straps are used for wooden connections
- 18. Ropes are used for connections
- 19. Wood is preserved at the foundation level with oil and petrol mixture
