BANGLADESH

Area-Based Approaches to Foster Community in Refugee Camps

PROJECT DESCRIPTION

Location: Zone BB, Kutapalong Camp, Cox's Bazaar

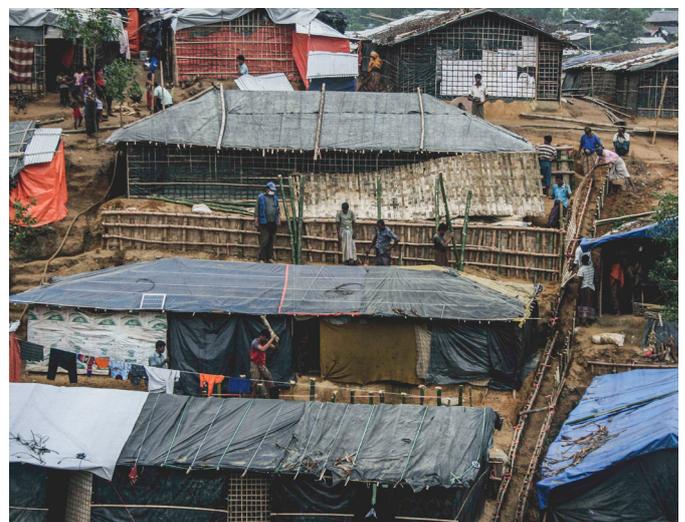
The community working on installing drainage and retaining walls.
Photo credit: Jamie Richardson / CRS

- Building of retaining walls made of sandbags and bamboo, 'stitched' back using rope and pegs—a technique used in WW1 trench construction.
- Creation of steps made from bamboo and earth backfilled.
- Construction of drainage channels to remove rain water and water from washing and other domestic activities. The bamboo-lined channels were constructed with cement lining to the base.
- Installation of new boreholes, pumps and pit latrines for water and sanitation.
- Installation of 22, 20W LED, solar street lights.
- Introduction of simple grow bags by Caritas agricultural specialists, who also provided plants and seeds so that families can grow vegetables.

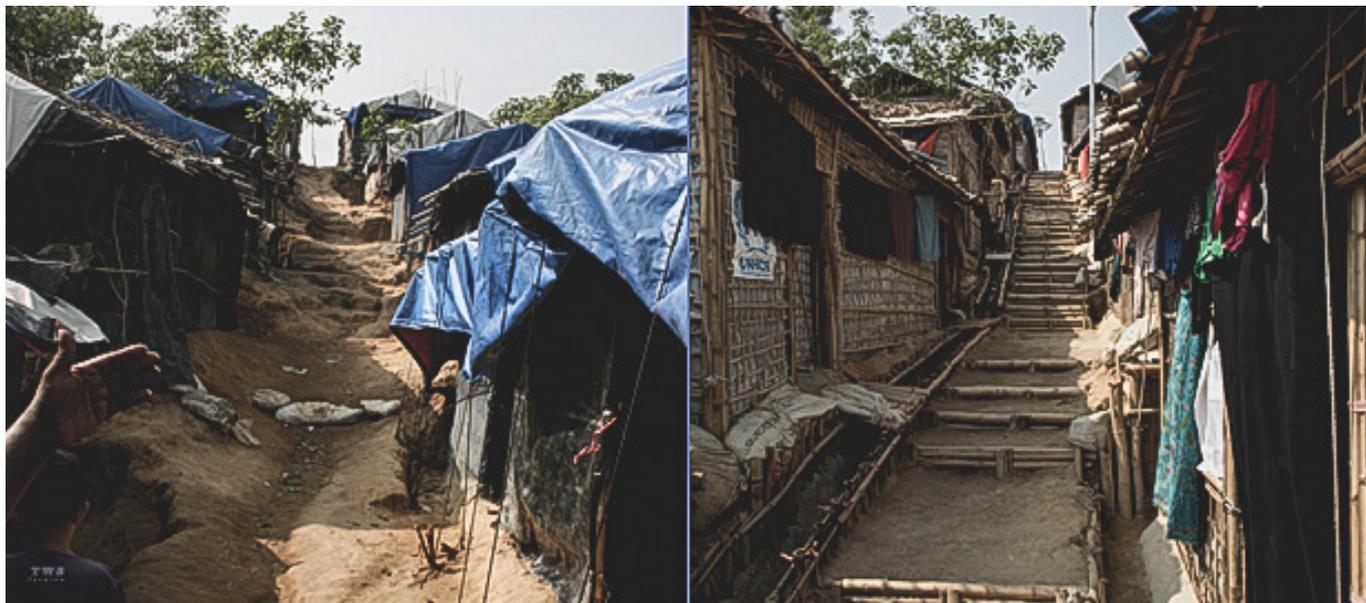
Images from the same street in November 2017 (left) and February 2018 (right) showing the extent of the improvements. Photo credit: Jamie Richardson (left), Christopher M. Reichert (right) / CRS
